POST-REMEDIAL ACTION REPORT FOR THE ADMINISTRATION WORK ZONE (WP-437/RU015)

WELDON SPRING SITE REMEDIAL ACTION PROJECT
WELDON SPRING, MISSOURI

JANUARY 2002 **REV. 0**

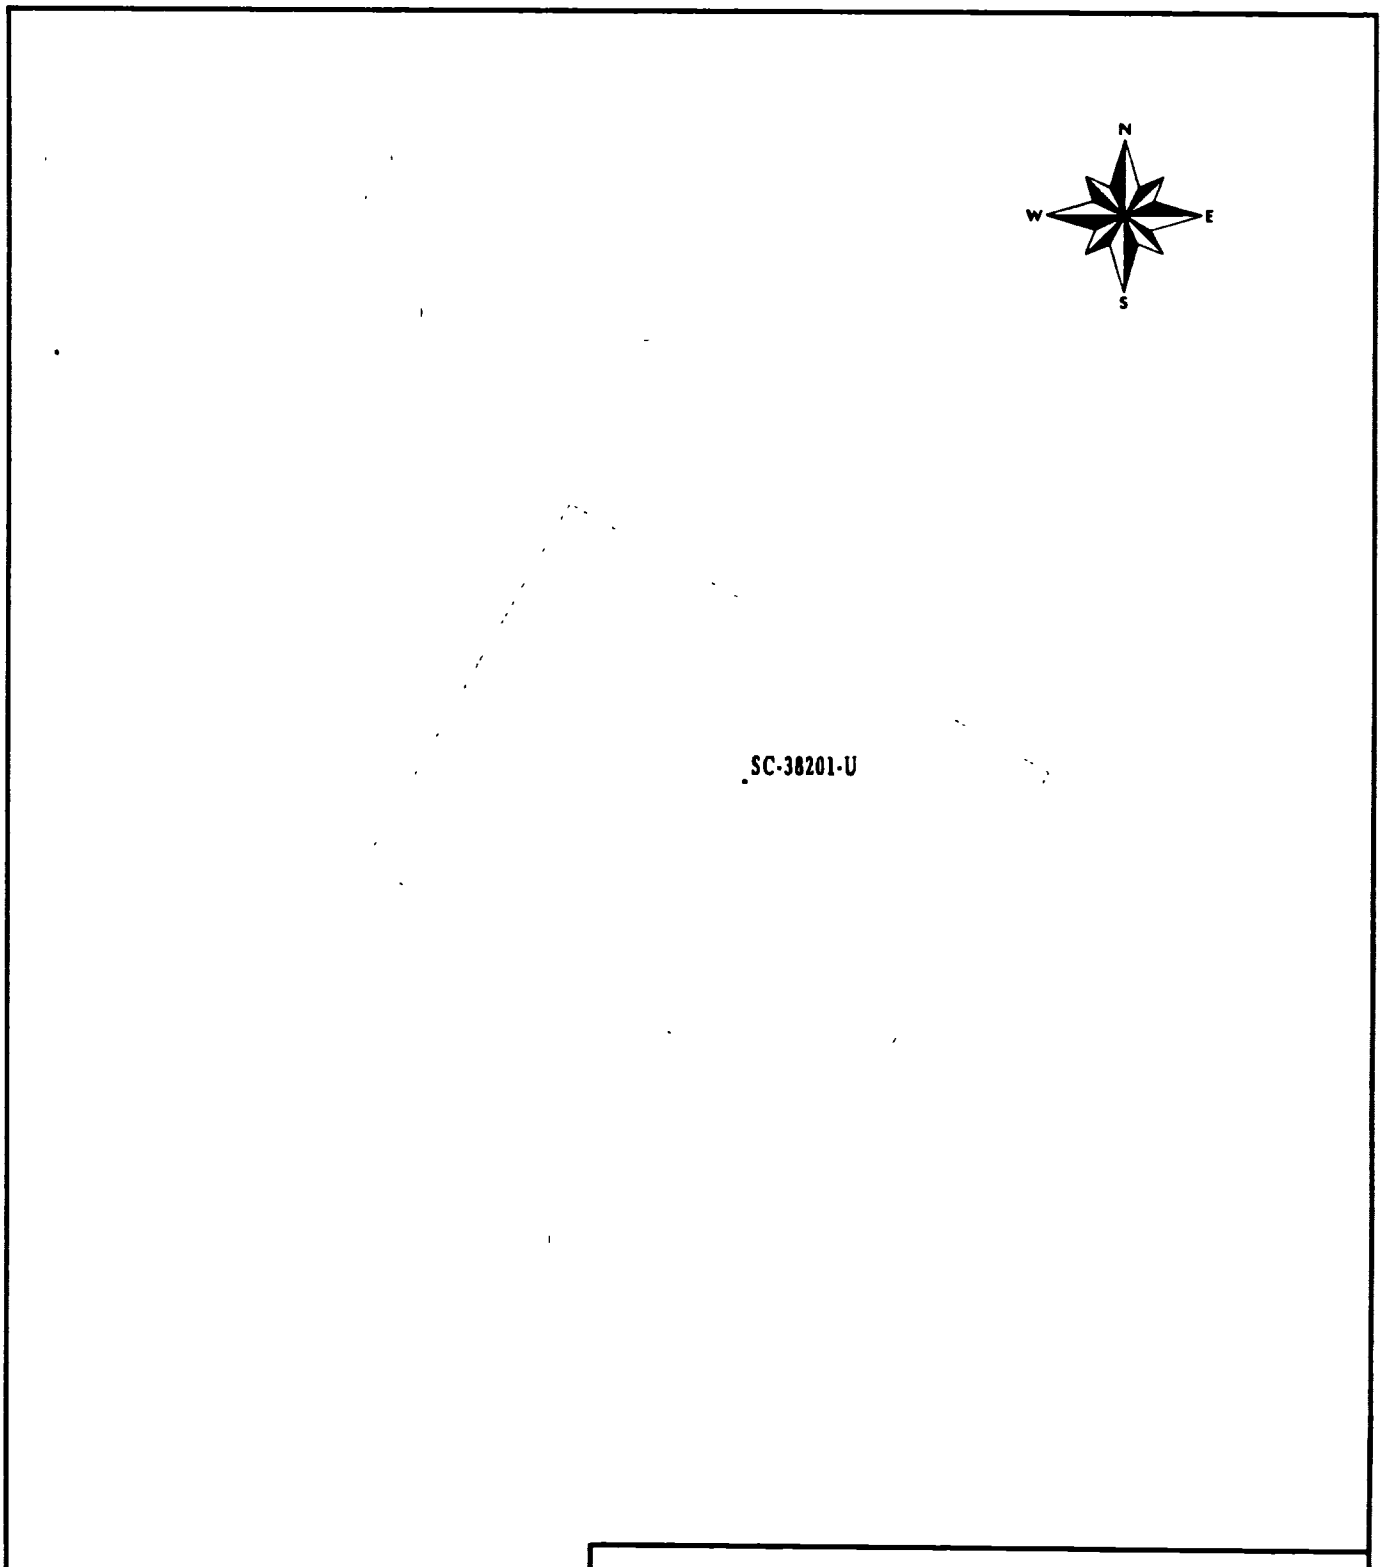
Figure: 4-1

LOCATION DESCRIPTION *This CU encompasses the decontamination pad that was located behind access control.*

GENERAL COMMENTS - *This CU was revised. See Section 2.1 for details. All final results are below ALARA.*

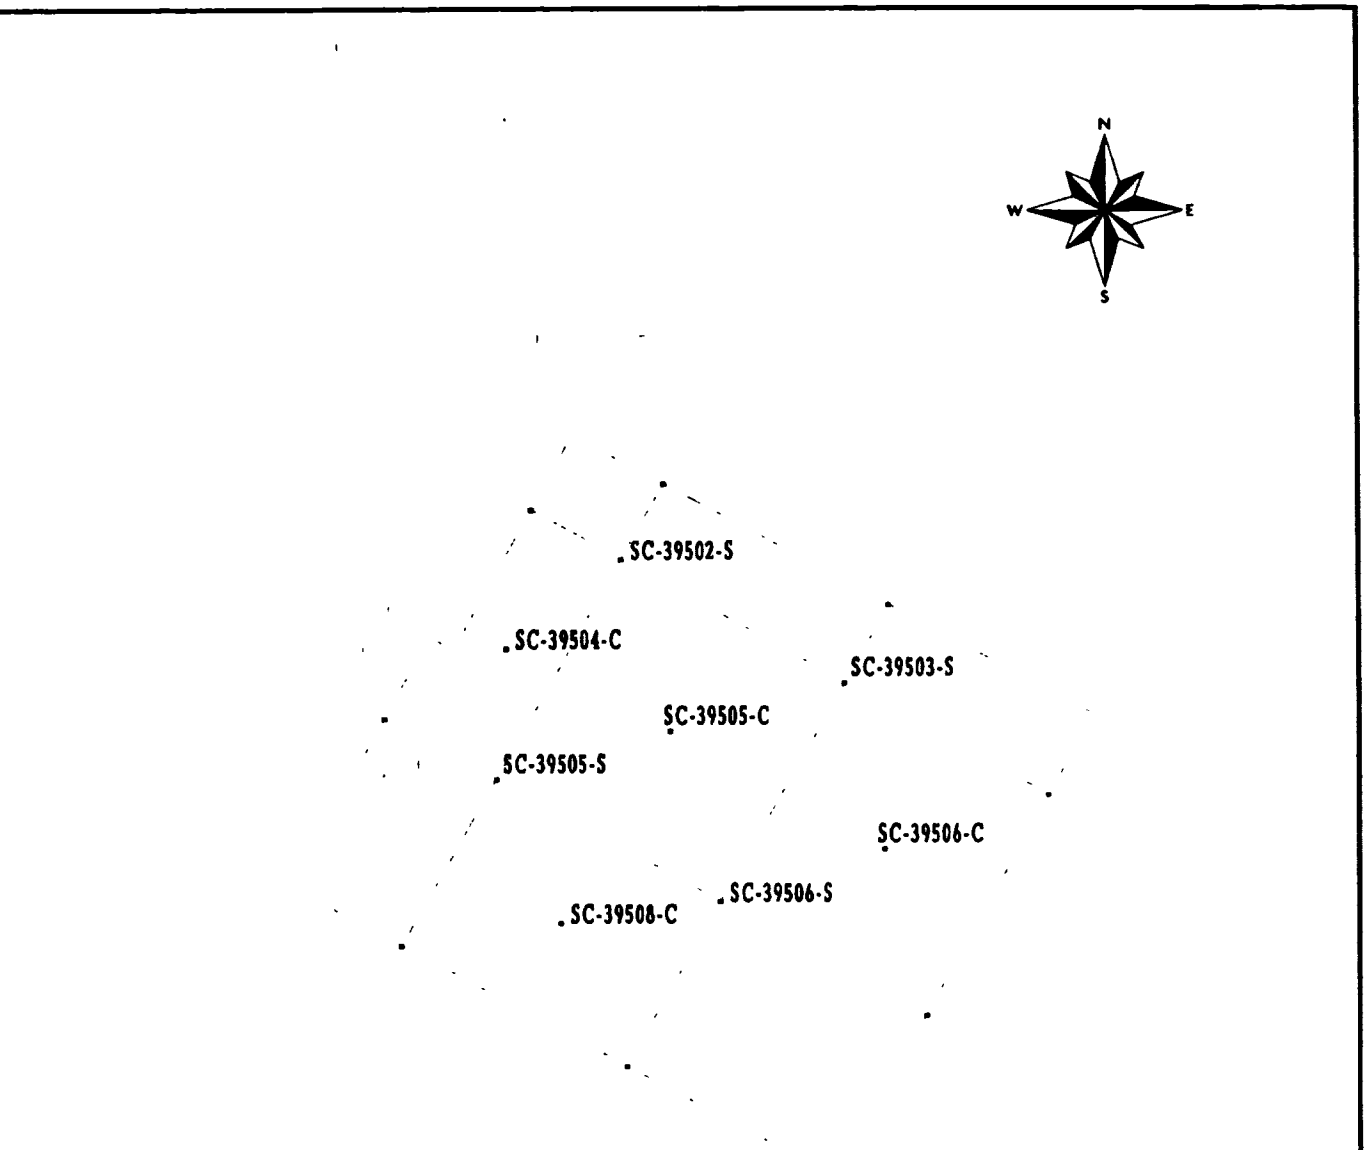
Figure: 4-4

LOCATION DESCRIPTION: *This CU is located northwest of access control at the site of a former air shaft.*

GENERAL COMMENTS - *This CU number was not identified in the the original sampling plan. It was added after further characterization took place in this work zone. See Section 2.1 for details. All final results are below ALARA.*

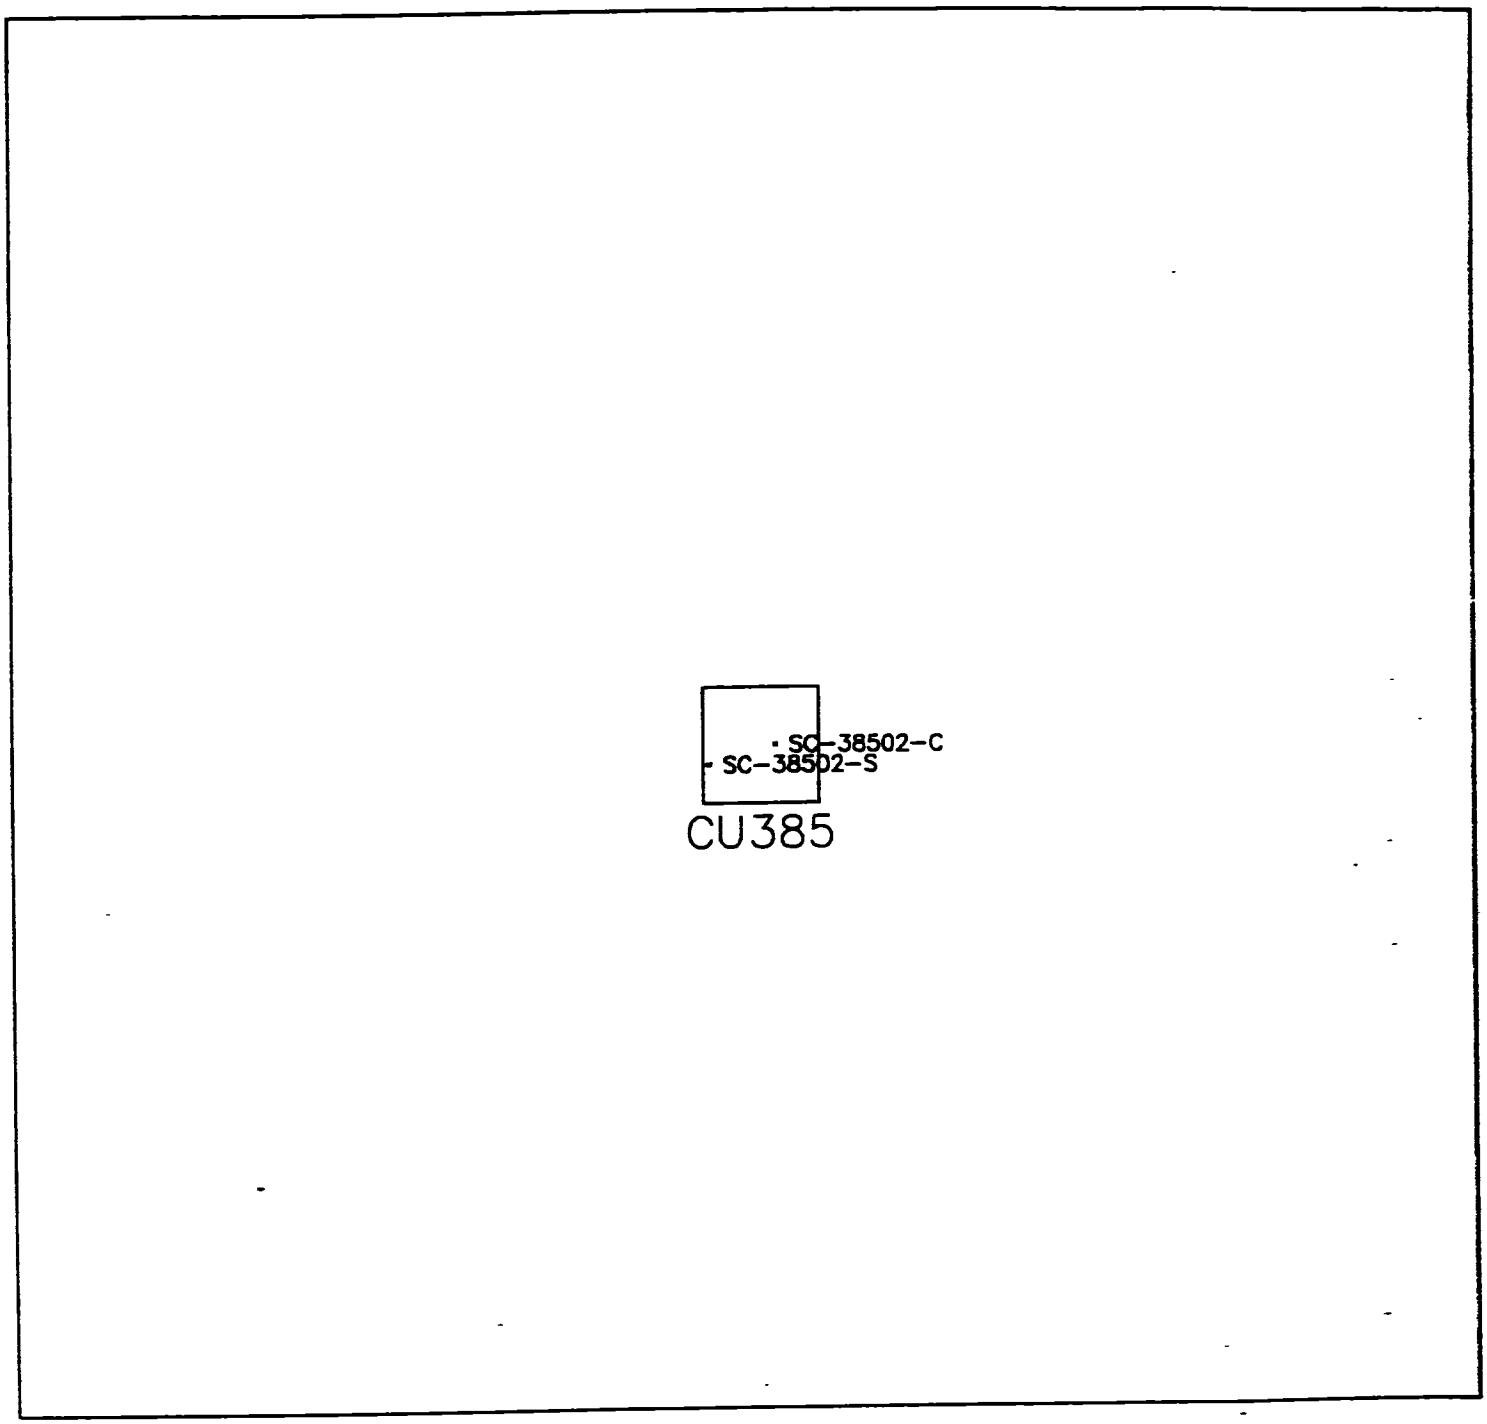
Radiation Survey Form WP 437, RU 15 CU 385

Meter Model #:	2221	Detector Model #:	NaI 2x2
Meter Serial #:	117617	Detector Serial #:	130764
Calibration Date:	10-13-00	Calibration Date:	09-24-00
Survey Date / Time:	02-08-00	Field Bkg.:	4500 cpm
Surveyor(s):	J. Rankin		
Comments:	All areas < 1.5 Background.
